NASA-DoD Lead-Free Electronics Project

Joint Test Report - Final

December 2011

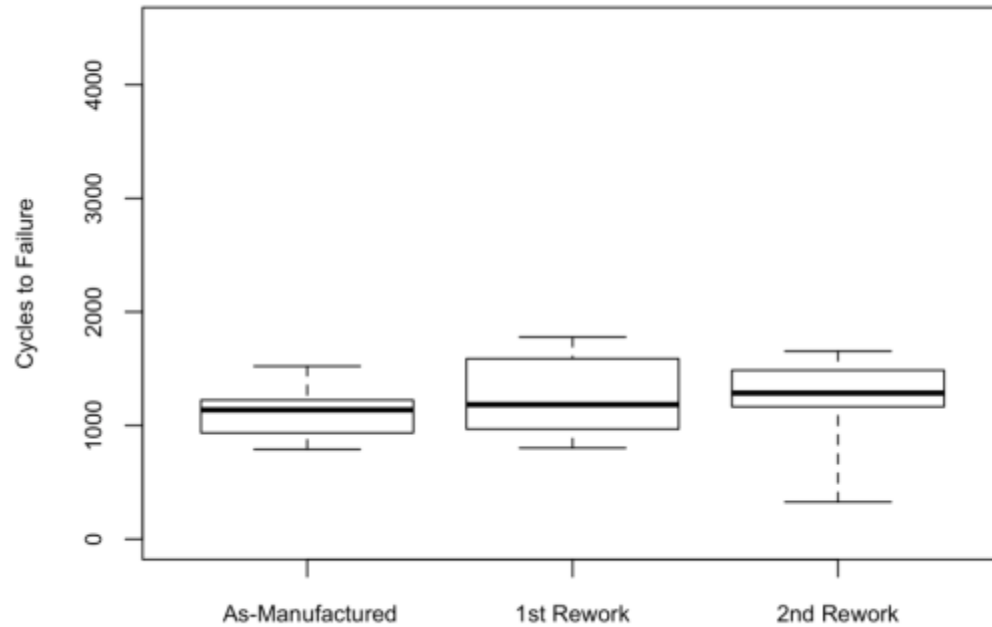
Figure 211 - Box and whisker plot comparing thermal cycles to failure for SnBi finished TSOP's originally soldered with SN100C and reworked 1 or 2 times with SnBi finished TSOP's soldered with eutectic SnPb. No differences in cycles to failure between the as-manufactured and reworked conditions were considered statistically significant.

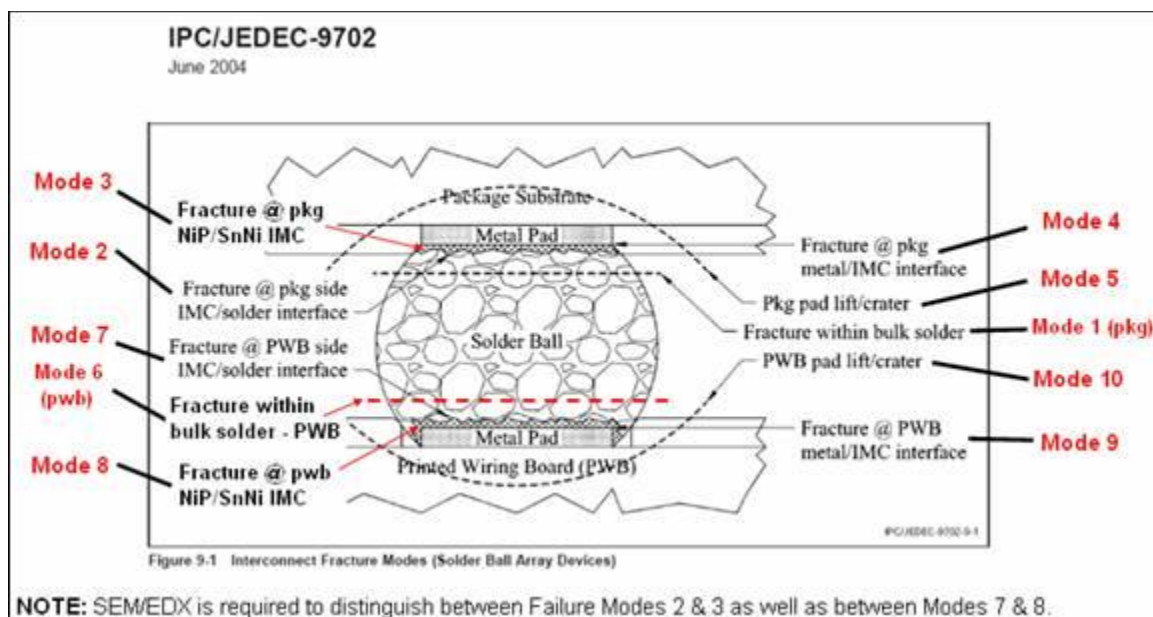
This test determines the resistance of board level interconnects to board strain induced by dynamic bending as a result of drop testing. Boards tested using this method typically fail either as interfacial fractures in the solder joint (most common with ENIG) or as pad cratering in the component substrate and/or board laminate (Figure 212). These failure modes commonly occur during manufacturing, electrical testing (especially in-circuit test), card handling and field installation. The root cause of these types of failures are typically a combination of excessive applied strain due to process issues and/or weak interconnects due to process issues and/or the quality of incoming components and/or boards.

Figure 212 - Interconnect Fracture Modes (Solder Ball Array Device) IPC 9702

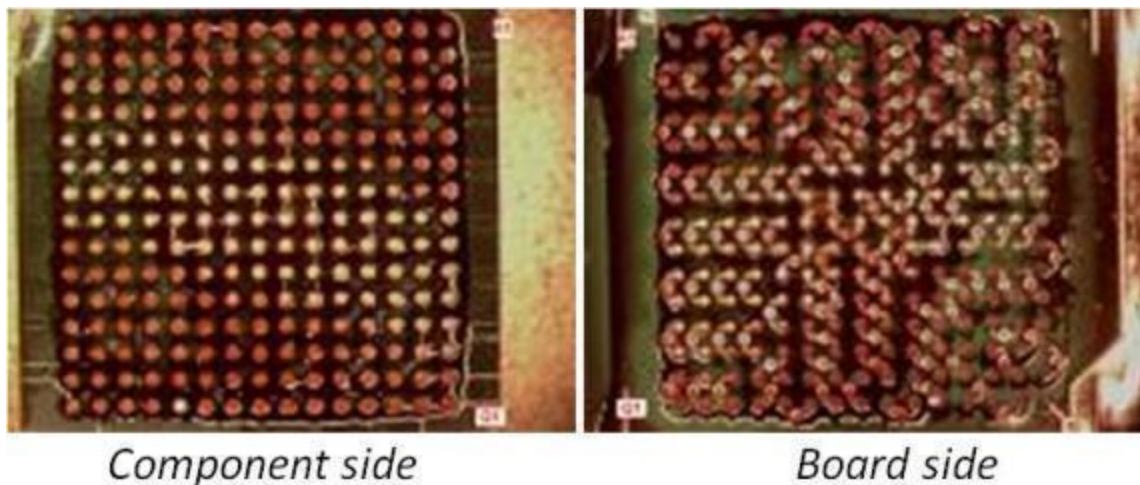
The main focus of the NASA drop test failure analysis was the 225 I/O plastic BGAs. This was because the vast majority of electrical failures on the test vehicle were these larger PBGAs. All CSPs electrically passed drop testing. For the PBGAs there was a wide range in number of drops until failure: 40% failed electrically within less than 6 drops and 99% failed electrically by 20 drops. Less than 1% of non-BGA components electrically failed after 20 drops. Pad cratering was the predominant failure mode for all samples destructively analyzed. Dye-and-pry and cross-sections of failed joints are shown below; Figure 213 and Figure 214.

Figure 213 - Typical Pad Cratering seen on BGA225 after Dye-and-Pry

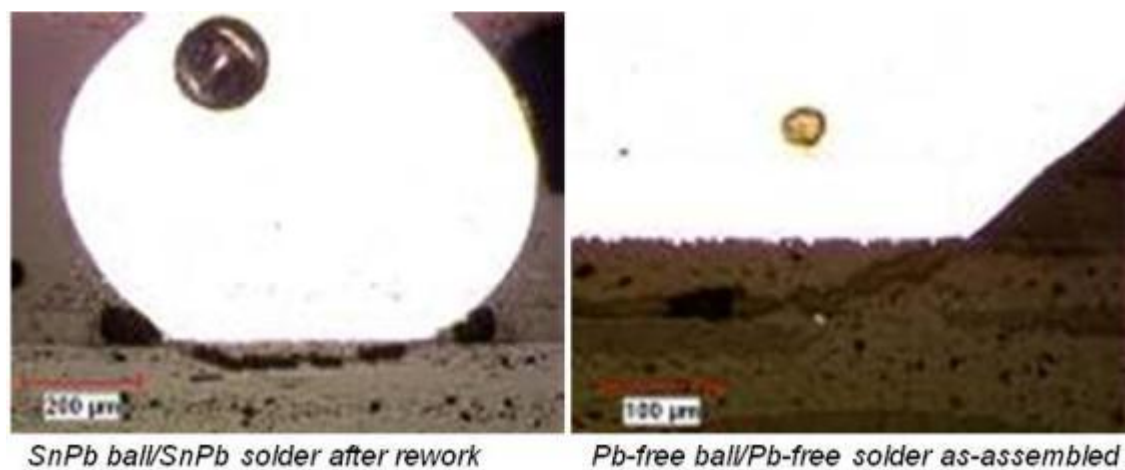
Figure 214 - Typical Pad Cratering seen on BGA225 after cross-section

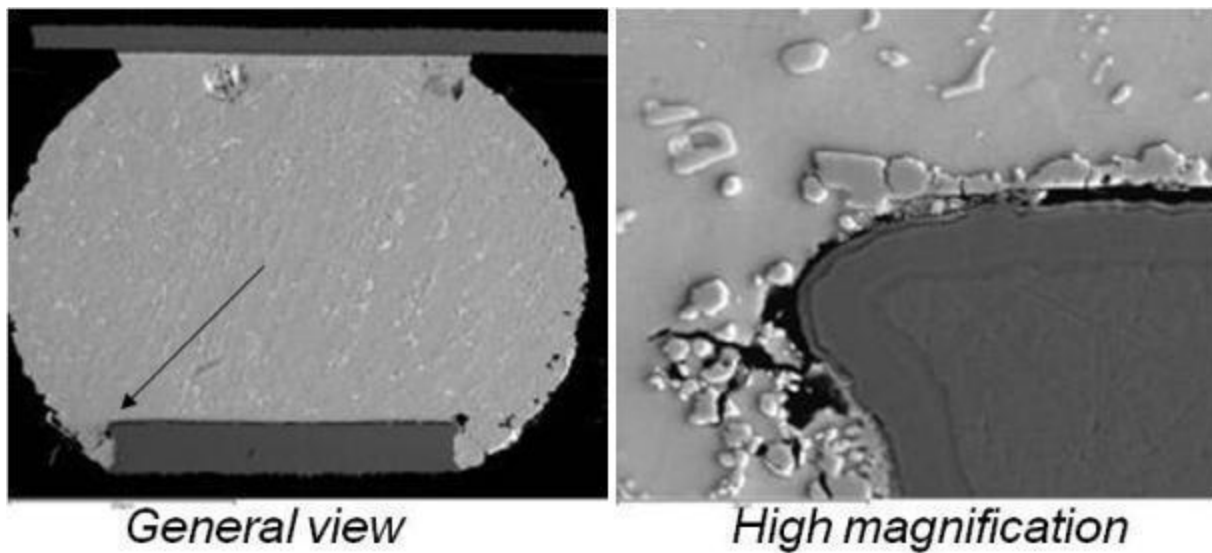
An additional mechanism that caused electrical failure in mixed solder joints was crack propagation through a low melting $\text{Sn}+\text{Pb}+\text{Ag}_3\text{Sn}$ ternary and/or $\text{Sn}+\text{Pb}+\text{Ag}_3\text{Sn}+\text{Cu}_6\text{Sn}_5$ quaternary eutectic accumulation layer at the board or component interface depending on sample history. In as-assembled condition the crack grew between the intermetallic layer and the bulk solder at the board side and after rework the more susceptible location was the interface between the intermetallic layer and the bulk solder at the component side; Figure 215. For the ENIG finished boards the predominant failure modes were brittle intermetallic cracking on both board and component sides.

Figure 215 - SEM of Brittle Intermetallic Failure on BGA225

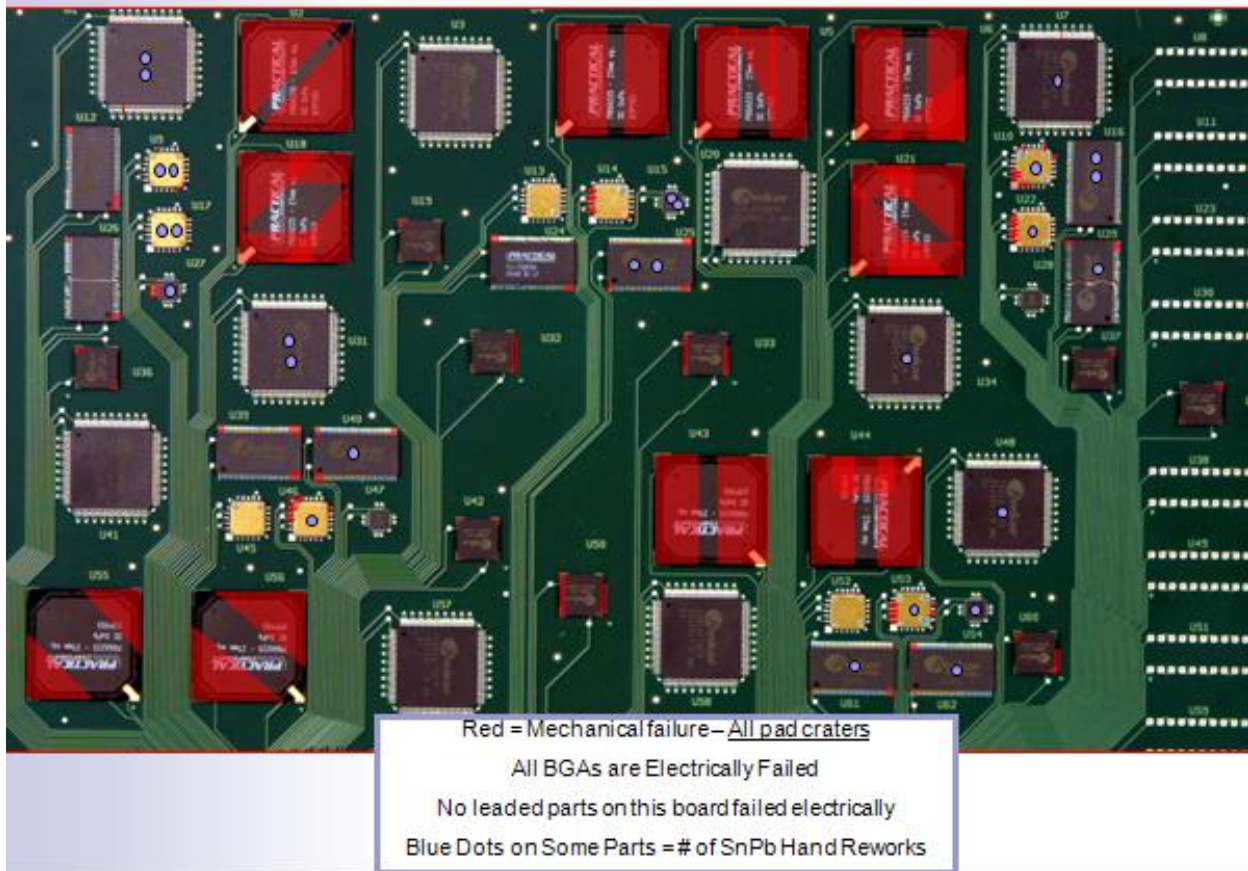
One of the cards tested, which had no electrically failing leaded parts, was chosen for dye & pry of all 63 parts in order to map the mechanical damage. Figure 216 summarizes the mechanical failure (red overlay) of one board after 20 drops at 500G. In-situ electrical data on BGAs showed that some PBGAs failed after as little as 5 drops – this implies that mechanical failure may have occurred after even fewer drops. Interesting to note that the board was held by posts in the 4 corners and as such the strain is not symmetrical across the card.

Figure 216 – Mechanical Failure Mapping

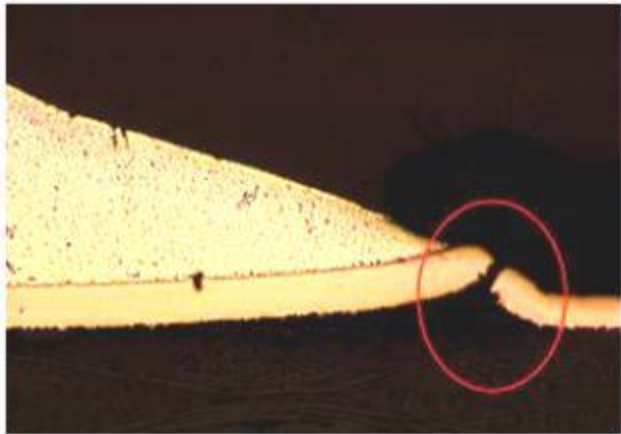
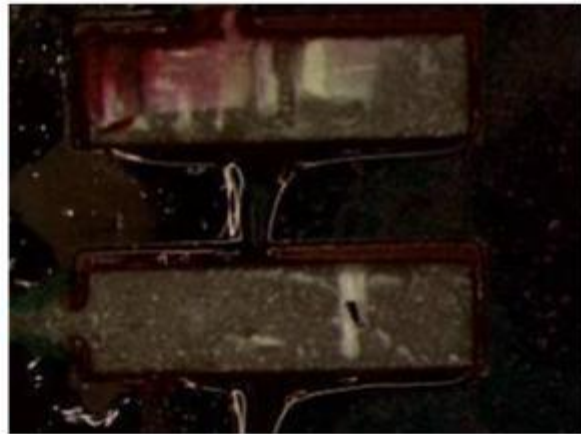
Pad cratering was the predominant failure mechanism in all components, as observed through both dye-and-pry and cross sectioning; Figure 217. In two cases the pad cratering was significant enough to break the trace and cause an electrical failure. However in most cases the trace remained intact and therefore no electrical failure was detected.

Figure 217 - Pad Cratering seen on CLCC-20

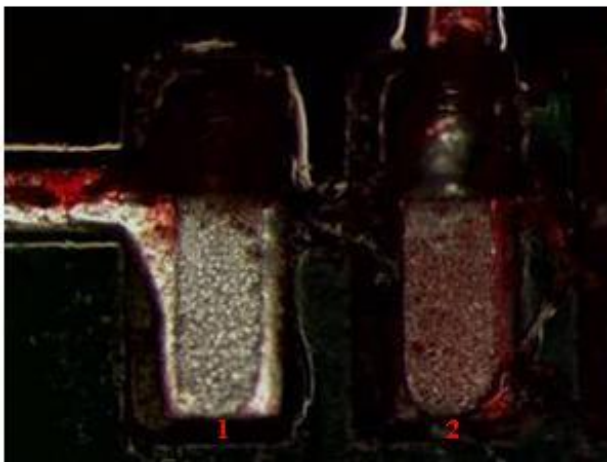
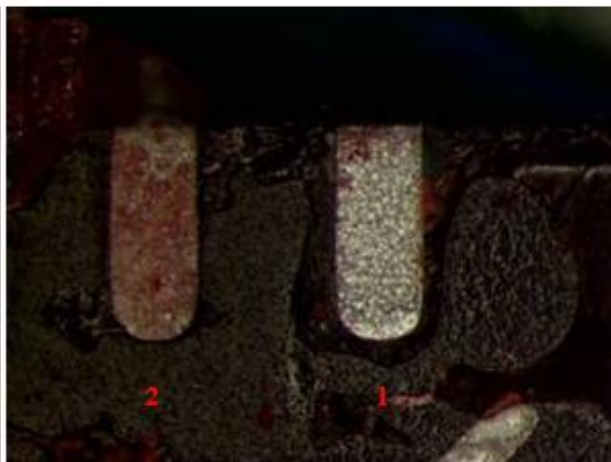
A small number of the analyzed solder joints had signs of solder fracture; however only in one case did this lead to an electrical failure; Figure 218. This indicates that, for the most part, the solder fractures did not penetrate through the entire solder joint.

Figure 218 - Dye and Pry of a QFN-20 showing dye penetration through the bulk solder

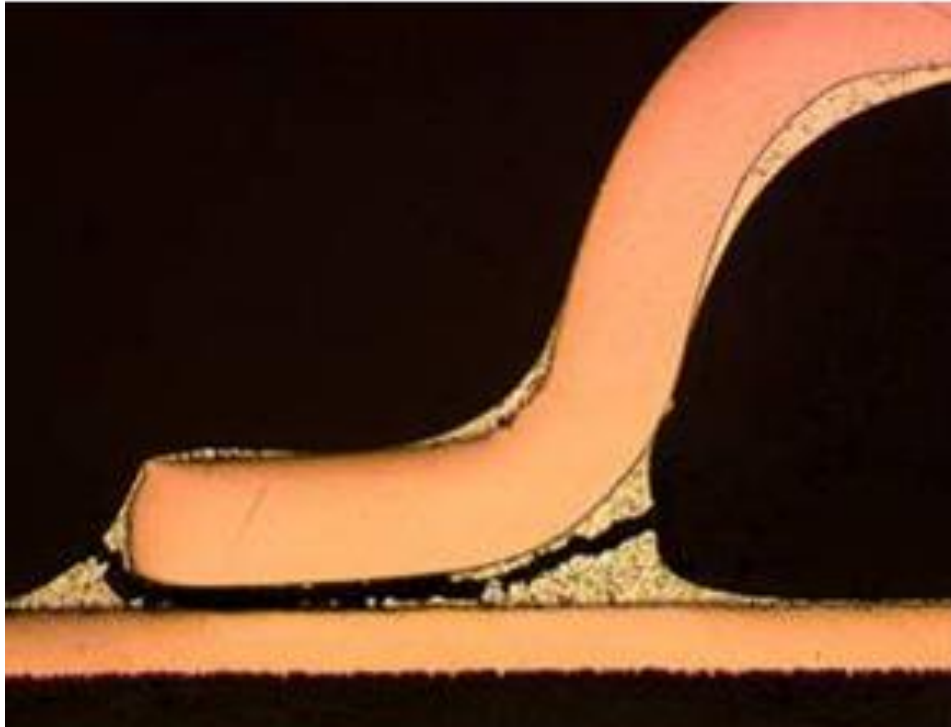
Pad cratering occurred in all package types (CLCC-20, QFN-20, TQFP-144, TSOP-50) but was less prevalent in the TQFP-144 in which pad cratering was observed on only one out of nine dye-and-pry samples. This is likely due to the structure of the part which has compliant copper leads on all four sides, ensuring efficient stress distribution. However, in one part, the interconnect failure was through the bulk solder in a fatigue failure mode; Figure 219.

Figure 219 – Fatigue Failure of TQFP-144 with 1x Rework as seen through cross sectioning

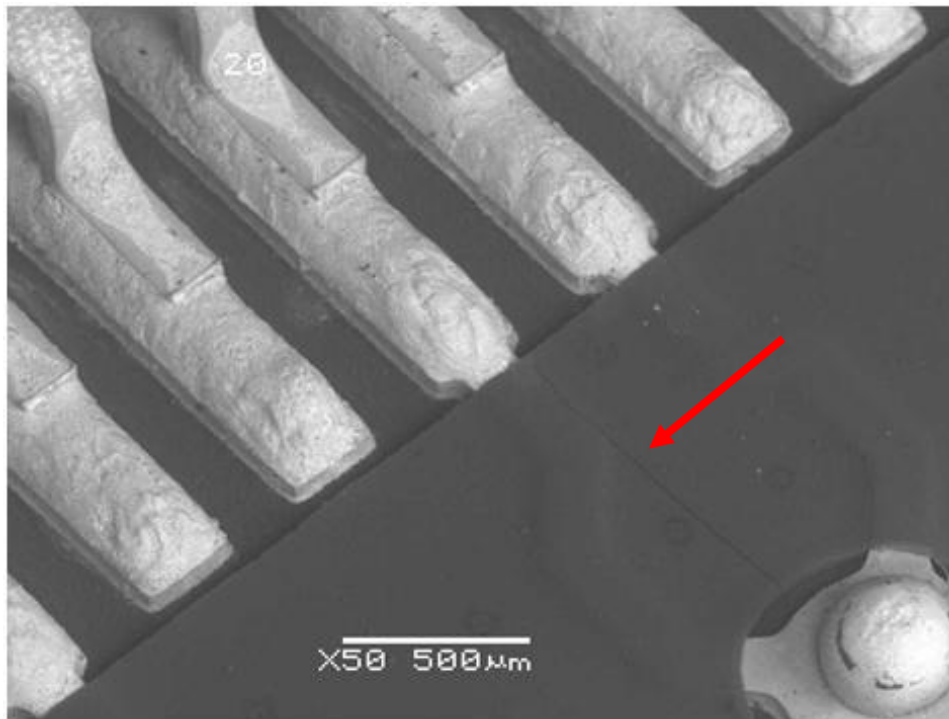
- Solder mask cracking found on test vehicle 21, TQFP components U34 (Figure 220) and U57 (Figure 221).
- Coplanarity issue causing open contacts on test vehicle 21, TQFP components U34 (Figure 222) and U57 (Figure 223).

Figure 220 - U34 TQFP, SEM Image, Solder Mask Crack near Lead 20 (X50)

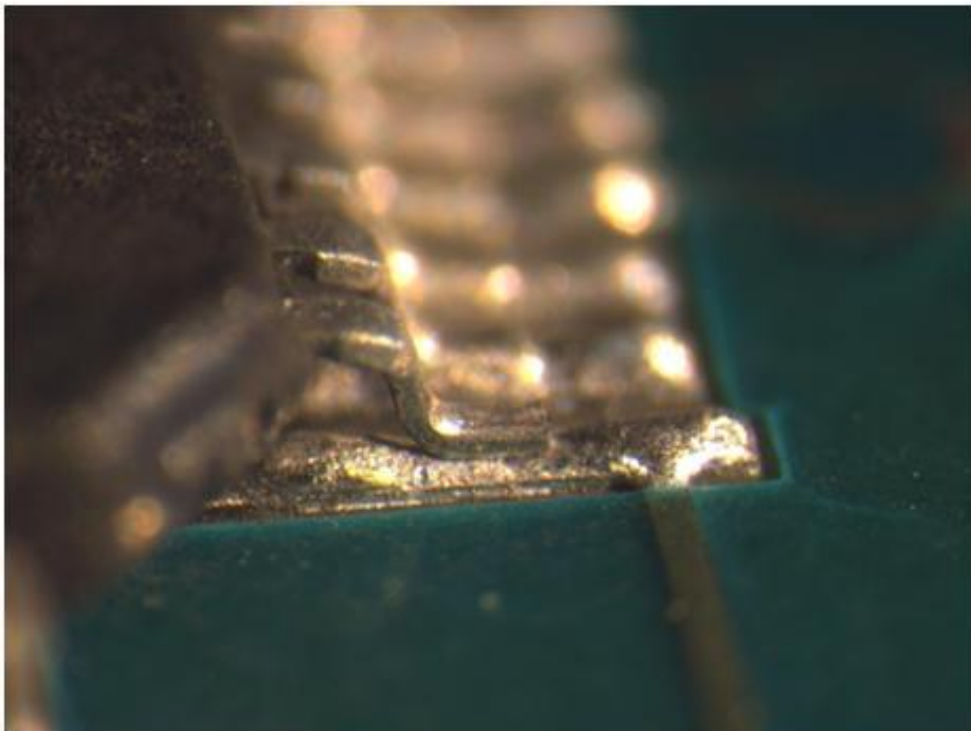
Figure 223 - U57 TQFP, No Solder Contact to Lead 1 (X49); Open due to Non Coplanarity

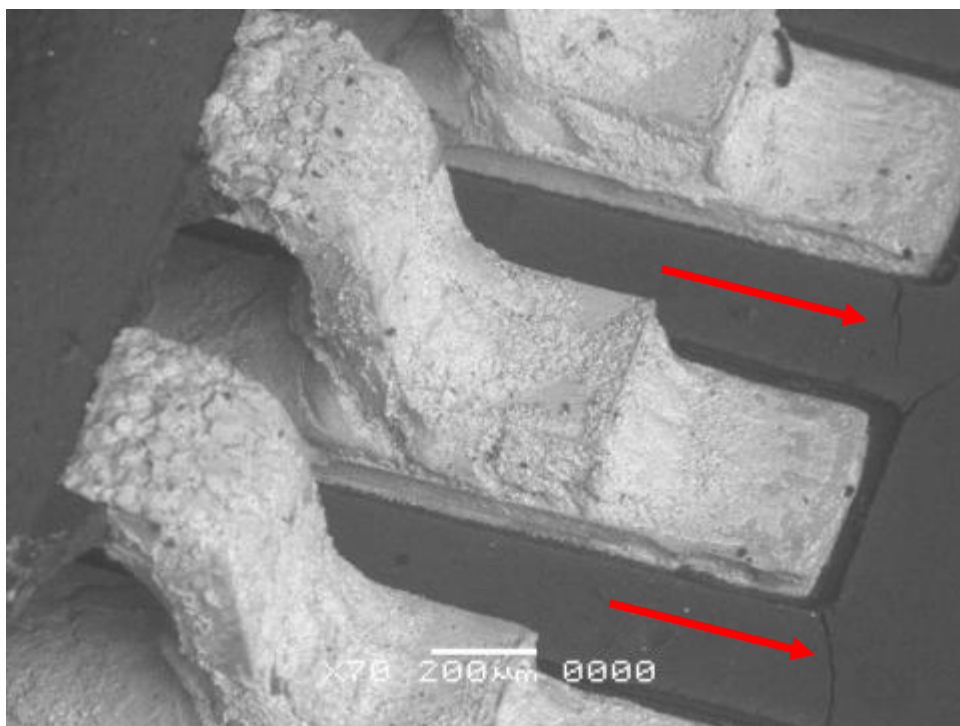
- Solder mask cracking found on test vehicle 119, TSOP component U39 (Figure 224).
- Solder mask cracking found on test vehicle 181, TSOP component U25 (Figure 225).
- Voids in solder joints, test vehicle 119, TSOP component U39 (Figure 226)
- Solder in the upper bend area of test vehicle 119, TSOP component U39 (Figure 227) and test vehicle 181, TSOP component U25 (Figure 228).
- Presence of Pb phase in the vicinity and along the cracks on both parts; test vehicle 119, TSOP component U39 and test vehicle 181, TSOP component U25.

Figure 225 - U25 TSOP, SEM Image, Lead 2 in Center, Lead 1 Left (X70)

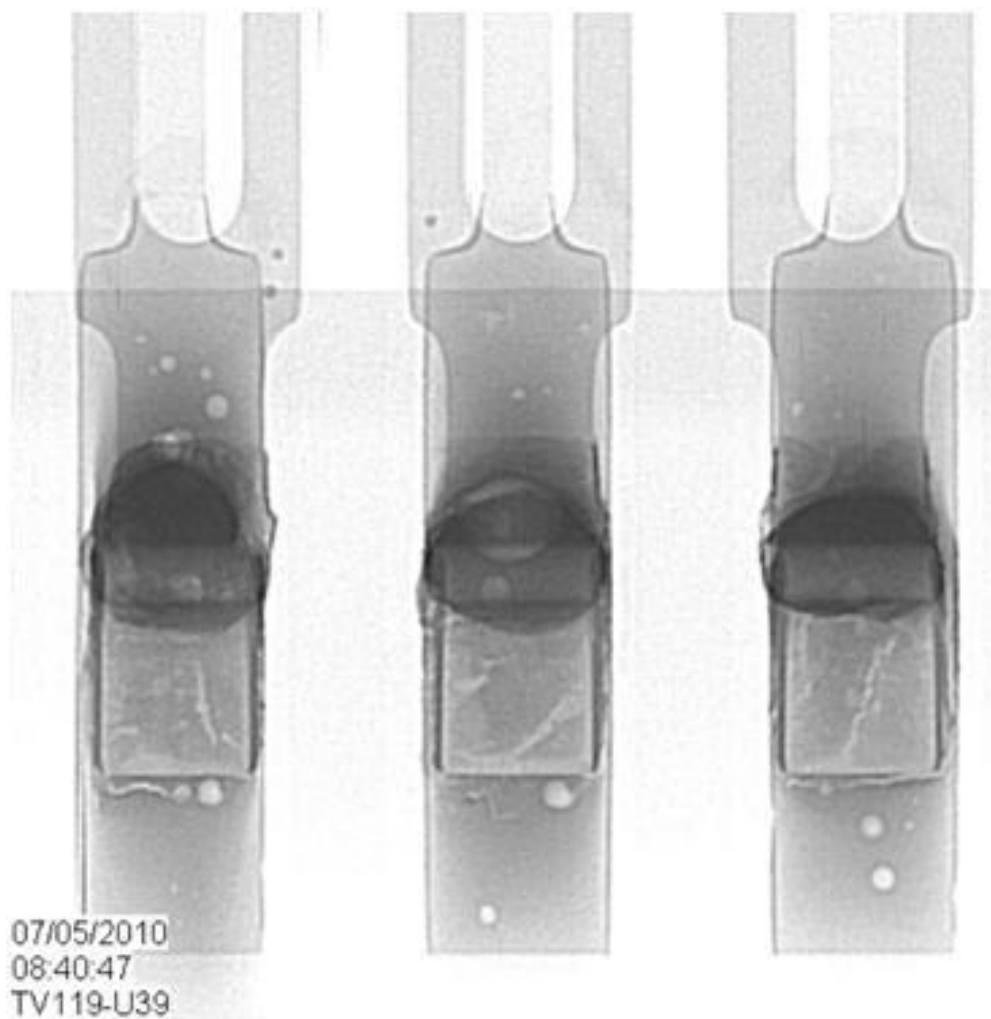
Figure 226 - U39 TSOP, X-ray Image, Leads 1-3, Voids in Solder Joints

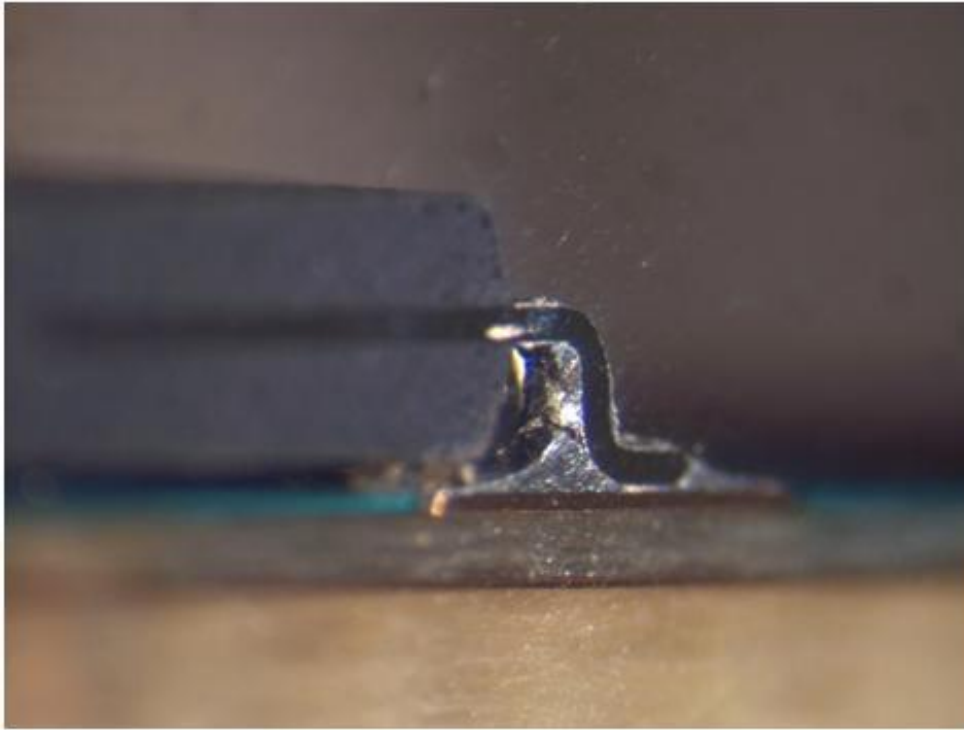
Figure 227 – U39 TSOP, Cross Sectional View of Lead 1, Solder (X49)

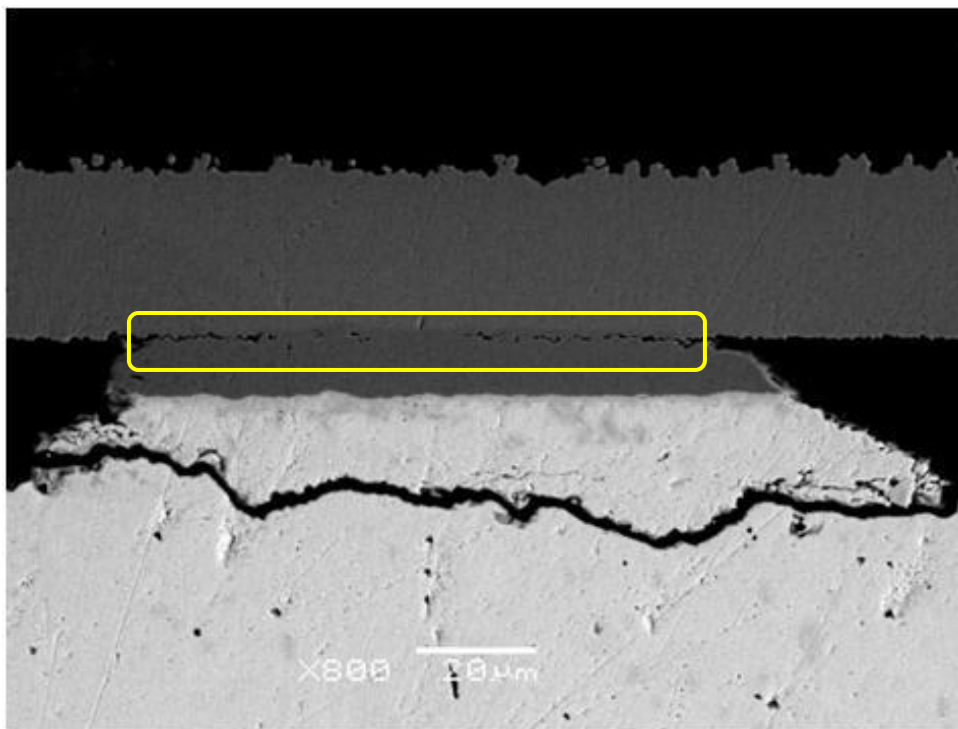
- Solder mask cracking found on test vehicle 119, CSP component U36 (Figure 229).
- Cracks developed at SnCu phase, PCB interface; test vehicle 119, CSP component U36 (Figure 230).
- Cracks developed at Sn rich phase adjacent to Ni barrier; test vehicle 119, CSP component U36 (Figure 231).

Figure 231 - U36 CSP, SEM image of Ball A2, Component Side (X800)

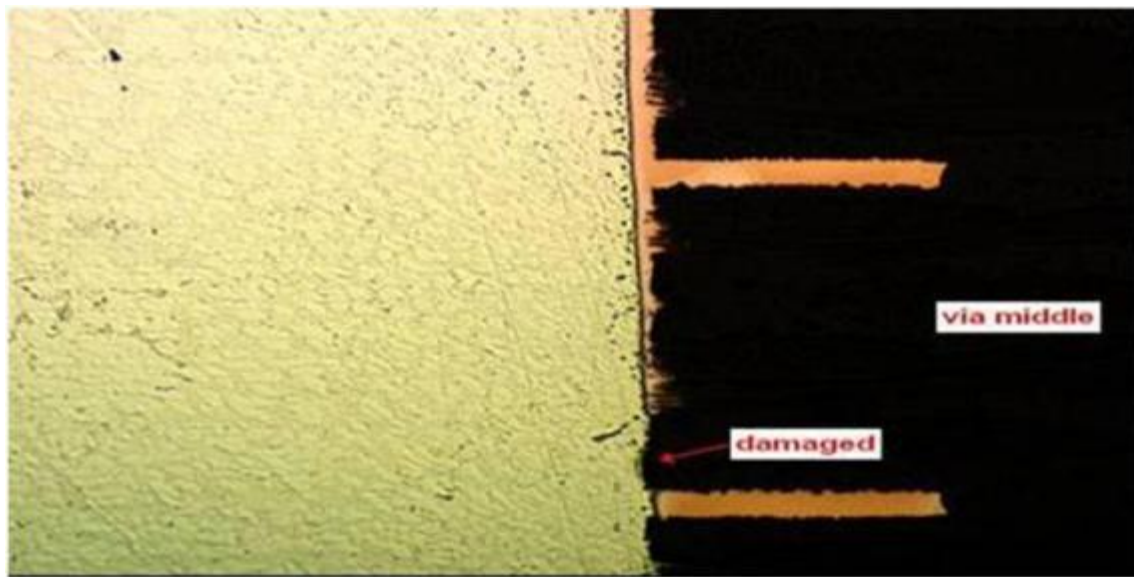
Figure 253 - Damage example – PTH trace disconnected from PTH barrel

Figure 253 shows a trace that is disconnected from the PTH barrel and therefore represents a board defect resulting from excessive copper dissolution. DfX rules could redirect the location of these signal connections within the barrel towards the upper layers to minimize the risk of an interconnection failure in the product. Figure 254 illustrates a 0.036" PTH that was subjected to a total of 240 seconds of wave solder exposure. The PTH copper has been completely dissolved in the wave soldering process to nearly 30% of the plated-through-hole copper height.

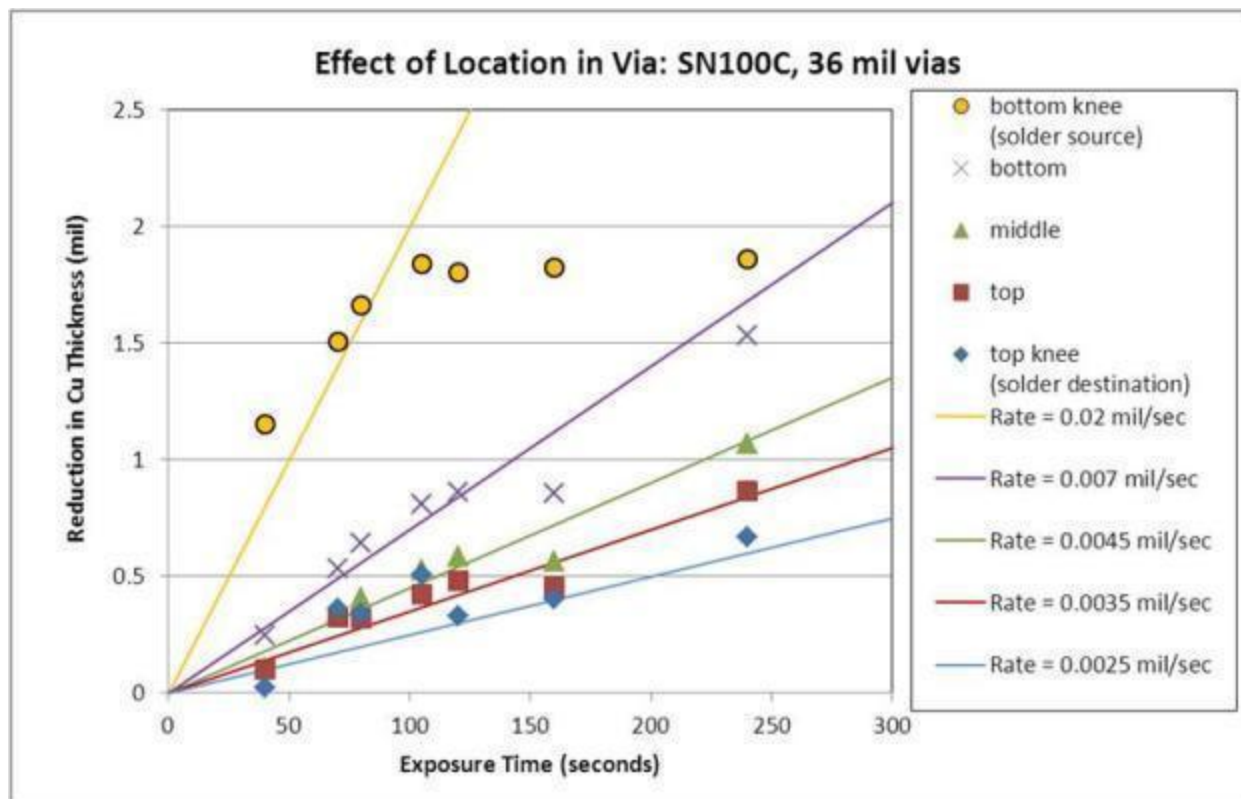
Figure 255 - Copper Dissolution for SN100C Alloy Illustrating Impact of Location on Via Height

As expected, the height of the plated through via also plays a role in the copper dissolution issue. Increasing the exposure time to the molten solder wave causes greater plated through via copper dissolution. Figure 255 illustrates how copper dissolution rates vary as a function of plated via measurement location along the length of the via. The bottom knee location had complete copper dissolution after approximately 100 seconds but the top knee location suffered only a reduction

of 0.6 mils of copper after 240 seconds. This copper dissolution impact is important as product designers can make their designs inherently less vulnerable to the effects of copper dissolution by placing critical signal layers further from the printed wiring board lower half locations. Note that the dissolution rates shown in Figure 255 are specific to that particular via diameter and alloy. As will be shown in the subsequent sections of these reports, the smaller vias and other solder alloy showed significantly different rates of copper dissolution.

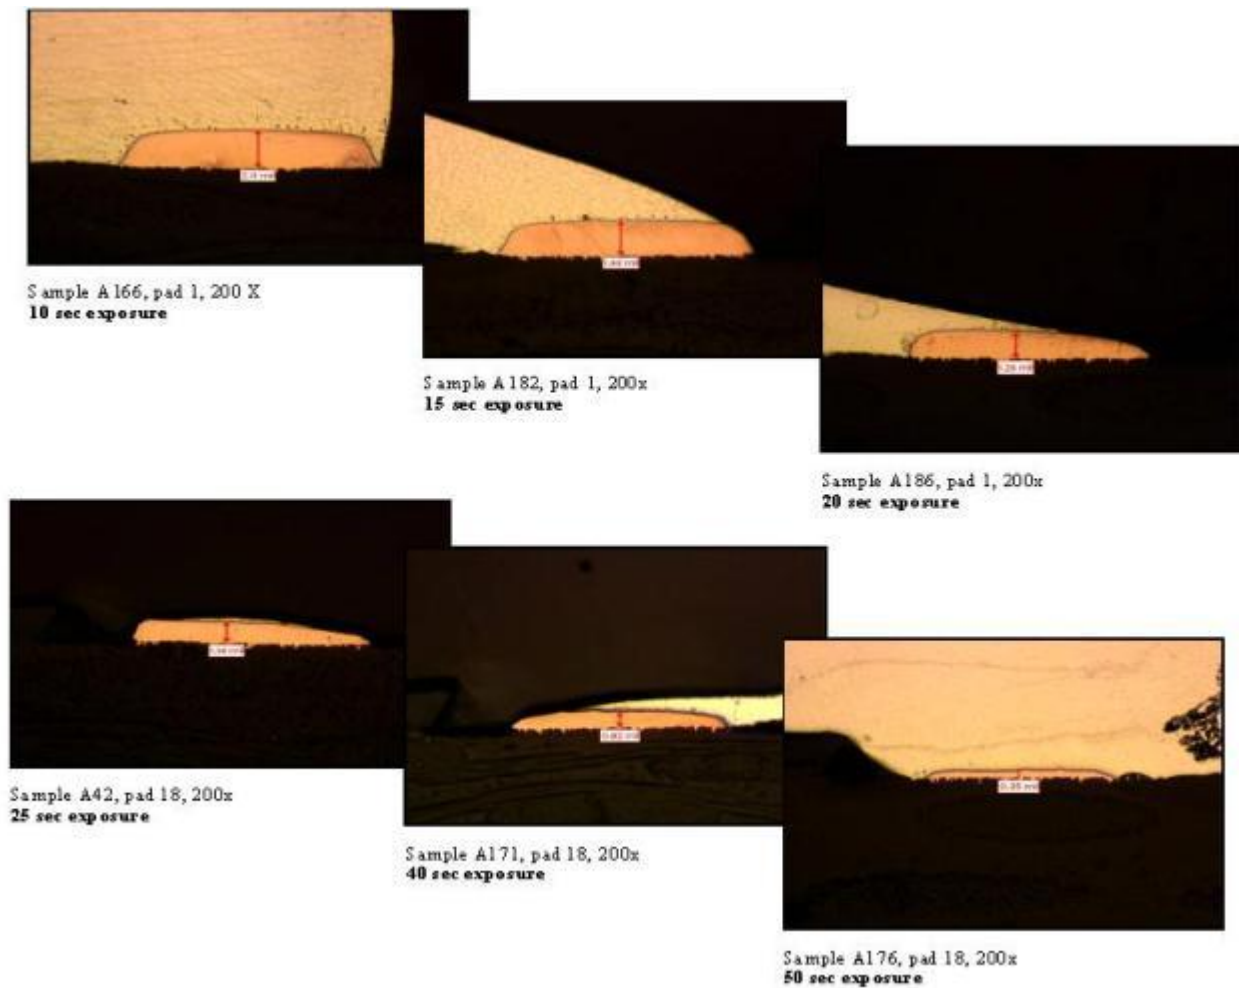
Figure 262 - Sequence of Pad Copper Dissolution by Exposure Time

Figure 262 shows the sequence of pad foil copper dissolution over a period of time. The slope, i.e. the copper dissolution rate, was found to be approximately 0.04 mils/second. This is very similar to the rate of copper dissolution determined at the knee of the DIP PTH for SAC305.

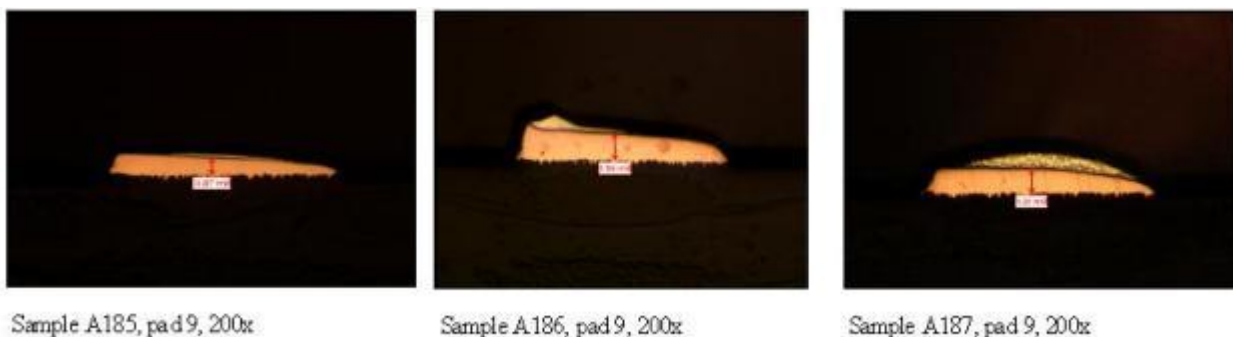
Figure 263 - Illustration of Copper Dissolution Rate Variance for A Specific Exposure Time

Figure 263 shows an example of the copper dissolution variance within a specific exposure time. The dynamic nature of the molten wave as it interacts with the plated through via or surface mount pad results in variation of remaining copper plating thickness, despite using tightly controlled test parameters and procedures. It should be noted that the copper dissolution rate for the SMT pads is not much different that of the PTH. This indicates that foil copper dissolves at nearly the same rate as the plated PTH copper.

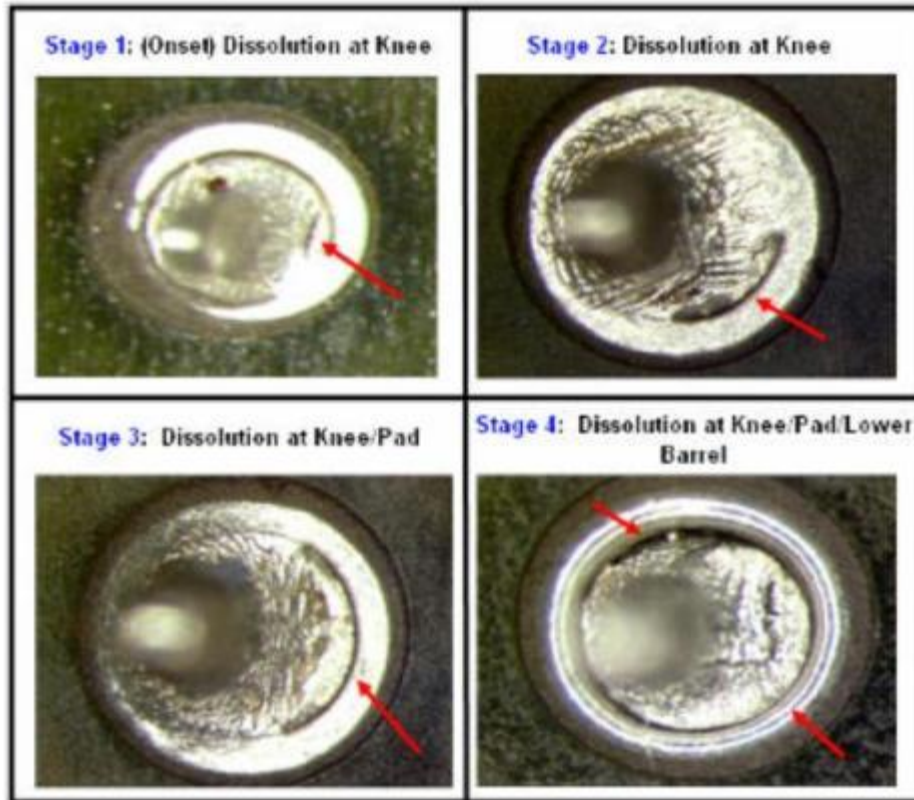
Figure 265 - Visual Indicators of Copper Dissolution(13): Knee- Pad- Barrel for Location of Copper Reduction Sequence

Visual inspection confirmed that the PTH catch pad and the knee of the PTH solder joint were the most susceptible locations for copper dissolution. The rate of copper dissolution is greater at this surface as compared to the inner barrel wall. Fillets at the knee may indicate a discontinuity at the location and may be a visual indicator for possible partial void/disconnection location. These visual indicators, illustrated in Figure 265 can be used by the operator to determine if there is an out-of-control process.

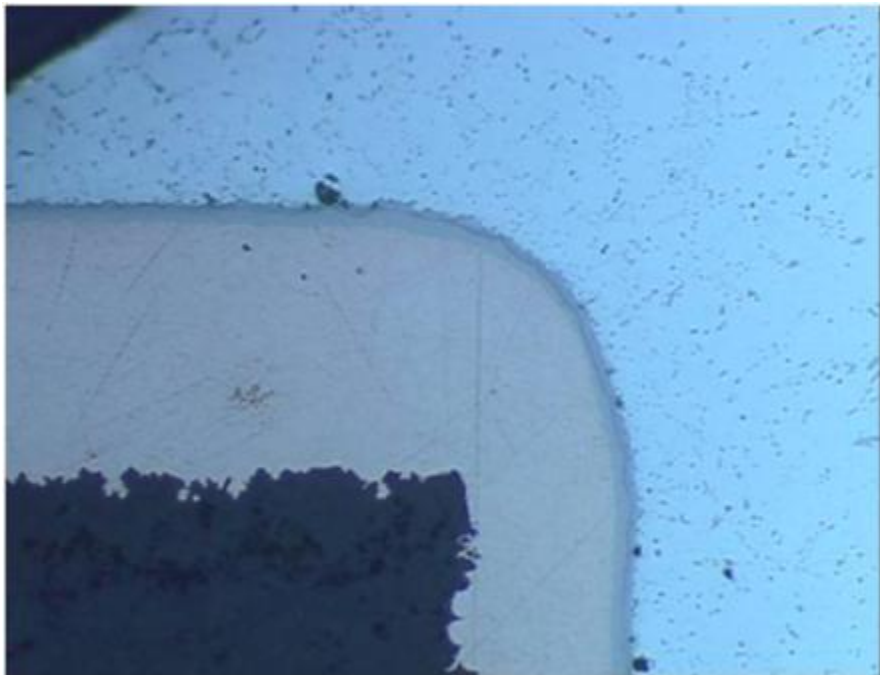
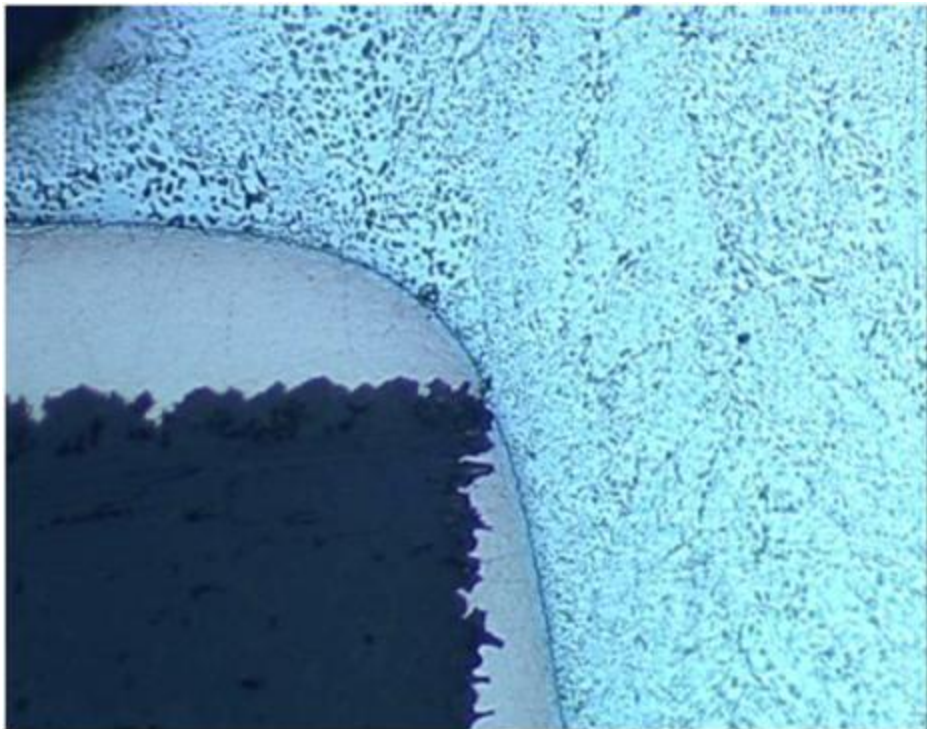
- The use of alternative printed wiring board surface finishes
The characteristics of some printed wiring assemblies, such as the number of copper layers and/or how the plated-through-holes are connected, may make lead-free solder alloy rework/repair unachievable. Consideration of, and risk analysis for, the use of alternative printed wiring board surface finish such as electroless nickel/immersion gold (ENIG) that are plated directly on copper with no intermediary plating layer such as nickel may be necessary. Figure 267 and Figure 268 illustrates the difference between two surface finishes. ENIG nickel plating on the left hand side show that the nickel plating protects 0.0015” of copper plating from copper dissolution even after 60 seconds exposure in a SAC305 flowing solder pot. The immersion tin surface finish shown on the right hand side allowed nearly completed dissolution of the copper plating at the knee of the plated-through-hole for the same 60 second exposure time.

Figure 267 - Impact of PWB Surface Finish on Copper Dissolution; ENIG

Figure 268 - Impact of PWB Surface Finish on Copper Dissolution; Immersion Tin
